**Flood Control Project Maintenance
Levee Inspections**

Fall 2018 Levee Maintenance Deficiency Summary Report

San Joaquin River Basin

Reclamation District No. 2063 Crows Landing

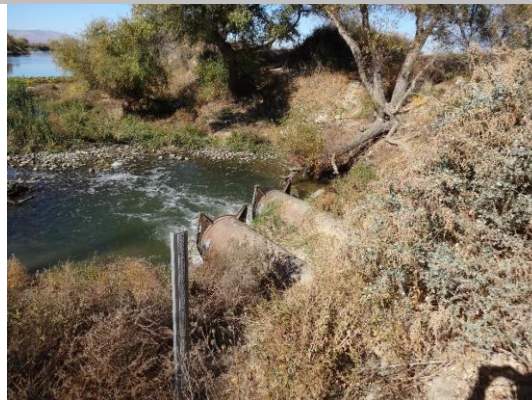
Photo 1 of 3 : UCIP_FA_2018_50218_43204.jpg

Comment Code						
Inspector Comment						
FS_ID:50218						
DS_ID:22076						
EP_NO: N/A						
Repair Type: No Action Needed						
Crossing Status: Found						
UCIP Comments: 08/23/2016: WS flapgates were held open by a piece of wood. Pipes may be used temporarily for irrigation. (K. Fazel - UCIP)11/05/2013: working during the inspection. (P. Amatya - DWR)						
FIELD_STRUCT_DESC: [Lateral Drain No. 5] 1 of 2: 48-inch corrugated metal gravity drainage pipe through the levee, 25.5 feet below the crown. Slide gate in a corrugated metal pipe (CMP) riser on the waterside (WS) slope. Flap gate on the WS end. 70-foot-long cobble spillway to river. Installed by USACE in 1961. [Additional Reference(s): DWR Levee Log, 1992. USACE San Joaquin O&M Manual 6, September 1961, (HLM 1.35)].						
FS Date: 11/5/2013

WS view: two outfall CMP pipes on levee slope.

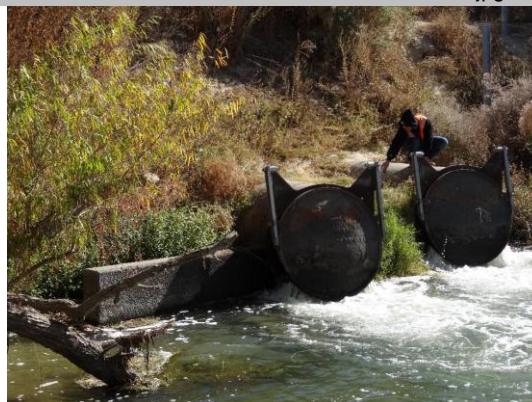
Photo 2 of 3 : UCIP_FA_2018_50218_43203.jpg

WS view: two outfall CMP pipes with flap gates on concrete headwall.

Comment Code						
Inspector Comment						
FS_ID:50218 DS_ID:22076 EP_NO: N/A Repair Type: No Action Needed Crossing Status: Found UCIP Comments: 08/23/2016: WS flapgates were held open by a piece of wood. Pipes may be used temporarily for irrigation. (K. Fazel - UCIP)11/05/2013: working during the inspection. (P. Amatya - DWR) FIELD_STRUCT_DESC: [Lateral Drain No. 5] 1 of 2: 48-inch corrugated metal gravity drainage pipe through the levee, 25.5 feet below the crown. Slide gate in a corrugated metal pipe (CMP) riser on the waterside (WS) slope. Flap gate on the WS end. 70-foot-long cobble spillway to river. Installed by USACE in 1961. [Additional Reference(s): DWR Levee Log, 1992. USACE San Joaquin O&M Manual 6, September 1961, (HLM 1.35)]. FS Date: 11/5/2013

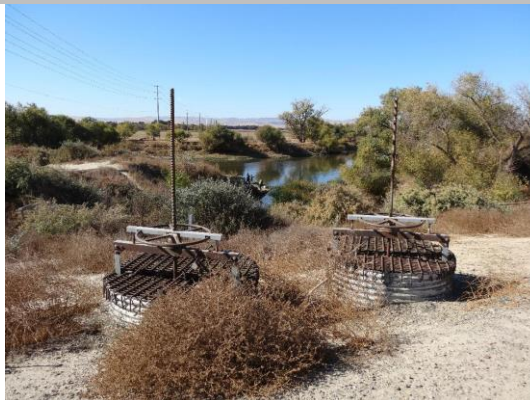
Photo 3 of 3 : UCIP_FA_2018_50218_43202.jpg

WS view: two slide gates in CMP risers on levee slope.

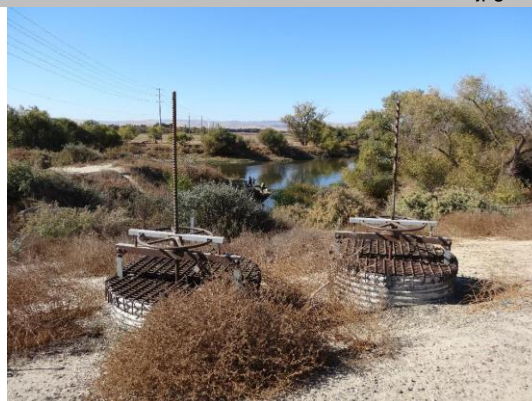
Photo 1 of 3 : UCIP_FA_2018_50217_43217.jpg

Comment Code						
Inspector Comment						
FS_ID:50217 DS_ID:22119 EP_NO: N/A Repair Type: No Action Needed Crossing Status: Found UCIP Comments: 08/23/2016: WS flapgates were held open by a piece of wood. Pipes may be used temporarily for irrigation. (K. Fazel - UCIP)11/05/2013: working during field inspection. (P. Amatya - DWR) FIELD_STRUCT_DESC: [Lateral Drain No. 5] 2 of 2: 48-inch corrugated metal gravity drainage pipe through the levee, 25.5 feet below the crown. Slide gate in a corrugated metal pipe (CMP) riser on the waterside (WS) slope. Flap gate on the WS end. 70-foot-long cobble spillway to river. Installed by USACE in 1961. [Additional Reference(s): DWR Levee Log, 1992. USACE San Joaquin O&M Manual 6, September 1961, (HLM 1.35)]. FS Date: 11/5/2013

WS view: two CMP risers with slide gates on levee slope.

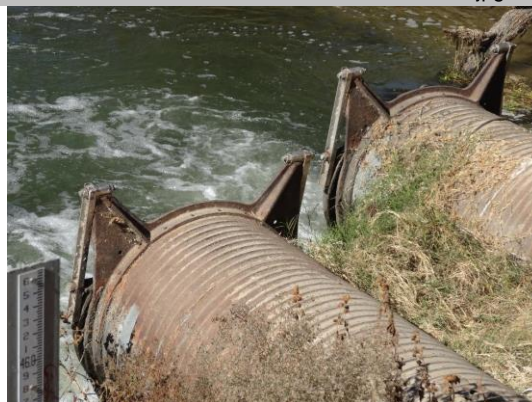
Photo 2 of 3 : UCIP_FA_2018_50217_43216.jpg

WS view: two CMP outfall pipes with flap gates on levee slope.

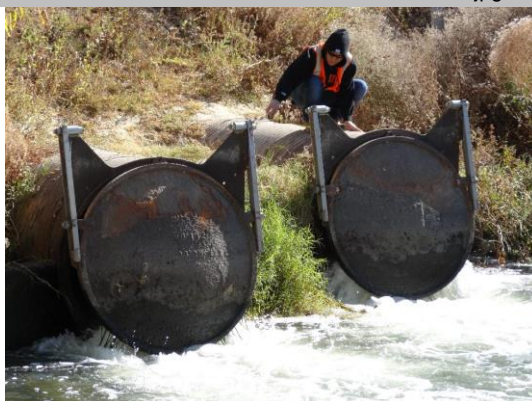
Photo 3 of 3 : UCIP_FA_2018_50217_43215.jpg

Comment Code						
Inspector Comment						
FS_ID:50217						
DS_ID:22119						
EP_NO: N/A						
Repair Type: No Action Needed						
Crossing Status: Found						
UCIP Comments: 08/23/2016: WS flapgates were held open by a piece of wood. Pipes may be used temporarily for irrigation. (K. Fazel - UCIP)11/05/2013: working during field inspection. (P. Amatya - DWR)						
FIELD_STRUCT_DESC: [Lateral Drain No. 5] 2 of 2: 48-inch corrugated metal gravity drainage pipe through the levee, 25.5 feet below the crown. Slide gate in a corrugated metal pipe (CMP) riser on the waterside (WS) slope. Flap gate on the WS end. 70-foot-long cobble spillway to river. Installed by USACE in 1961. [Additional Reference(s): DWR Levee Log, 1992. USACE San Joaquin O&M Manual 6, September 1961, (HLM 1.35)].						
FS Date: 11/5/2013

WS view: front view of two CMP outfall pipes with flap gates on levee slope.

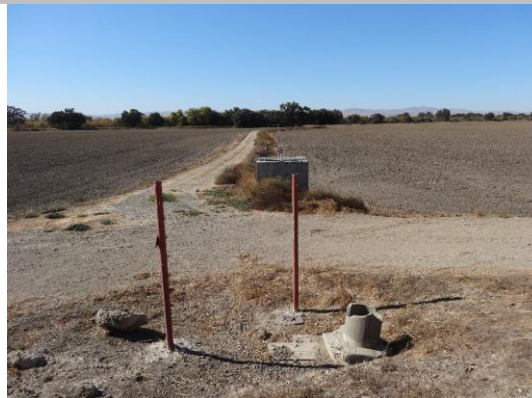
Photo 1 of 3 : UCIP_FA_2018_24404_43345.jpg

Comment Code						
Inspector Comment						
FS_ID:24404						
DS_ID:22078						
EP_NO: N/A						
Repair Type: Non-Urgent						
Crossing Status: Found						
UCIP Comments: 11/05/2013 Concrete distribution box with alfalfa valve not found at the waterward toe.Two steel standpipes and dismantled concrete standpipe on waterside levee toe.Concrete distribution box 50 ft off the levee center. (P. Amatya - DWR UCIP)						
FIELD_STRUCT_DESC: 30-inch corrugated metal irrigation discharge pipe through the levee, 16.5 feet below the crown. Slide gate in a concrete distribution box, 50 feet off the levee. Underground irrigation system. Installed by USACE in 1961. [Additional Reference(s): DWR Levee Log, 1992. USACE San Joaquin O&M Manual 6, September 1961, (HLM 2.11)].						
FS Date: 11/5/2013

WS view: concrete box (top), and a dismantled concrete pipe on levee toe.

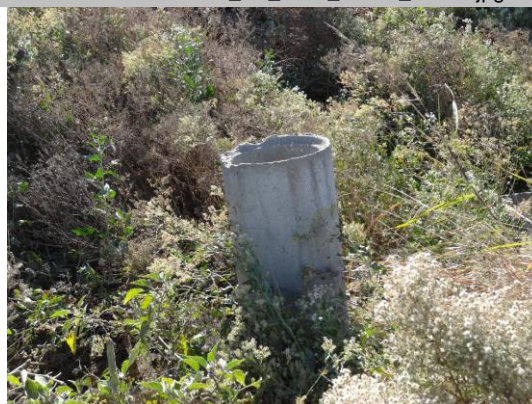
Photo 1 of 3 : UCIP_FA_2018_51823_43348.jpg

Comment Code						
Inspector Comment						
FS_ID:51823						
DS_ID:22081						
EP_NO: N/A						
Repair Type: No Action Needed						
Crossing Status: Found						
UCIP Comments: 11/05/2013 - concrete standpipe on waterside toe.- concrete distribution box on landside.- an alfalfa valve on waterside toe. (P. Amatya - DWR UCIP)						
FIELD_STRUCT_DESC: 30-inch corrugated metal gravity drainage pipe through the levee, 12 feet below the crown. Flap gate on the waterside (WS) end. Slide gate in a concrete distribution box on the landside (LS) end. Concrete U-shaped headwall on the WS end. [Additional Reference(s): DWR Levee Log, 1992. USACE San Joaquin O&M Manual 6, September 1961, (HLM 2.29)].						
FS Date: 11/5/2013

WS view: concrete standpipe on levee toe.

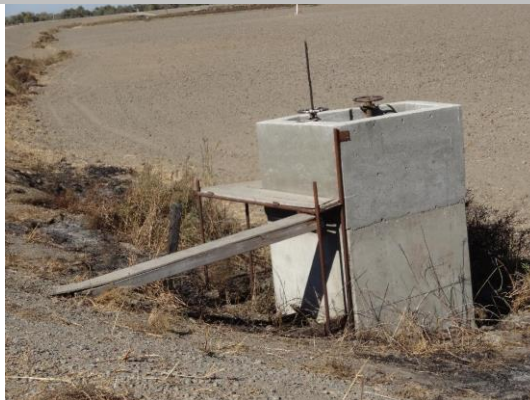
Photo 2 of 3 : UCIP_FA_2018_51823_43347.jpg

LS view: concrete distribution box and temporary walkway on levee toe.

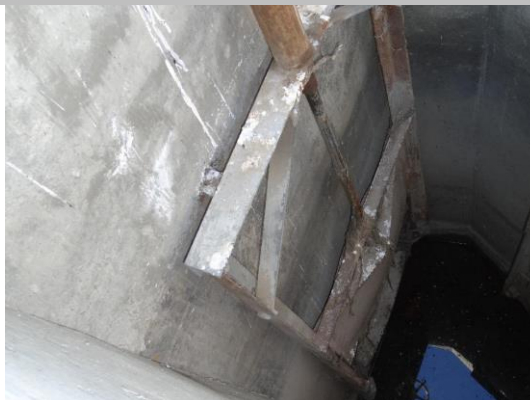
Photo 3 of 3 : UCIP_FA_2018_51823_43346.jpg

LS view: slide gate in concrete distribution box.

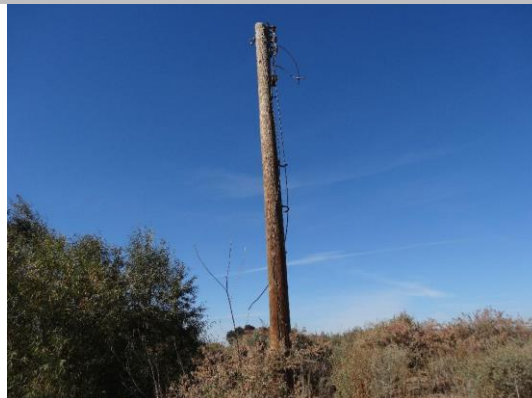
Photo 2 of 3 : UCIP_FA_2018_24427_43438.jpg

Comment Code						
Inspector Comment						
FS_ID:24427 DS_ID:22085 EP_NO: N/A Repair Type: Non-Urgent Crossing Status: Found UCIP Comments: 11/05/2013 Abandoned steel pipe and service pole on waterside. Pump not found on river bank. CMP riser on waterside slope. Slide gate not found in CMP riser. Steel pipe riser on waterside berm.Damaged PVC standpipe on waterside slope. (P. Amatya - DWR UCIP) FIELD_STRUCT_DESC: *ABANDONED* 24-inch corrugated metal irrigation discharge pipe through the levee, 10 feet below the crown. Slide gate in a corrugated metal pipe (CMP) riser on the waterside (WS) slope. 20-inch standpipe 3 feet from the landside (LS) toe. 12-inch pipe across the berm and into a CMP riser on the WS slope. Pump on riverbank. Installed by USACE in 1961. [Additional Reference(s): DWR Levee Log, 1992. USACE San Joaquin O&M Manual 6, September 1961, (HLM 2.46)]. FS Date: 11/5/2013

WS view: abandoned power pole on levee berm.

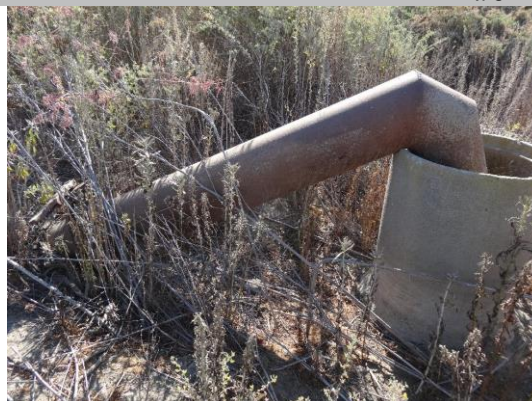
Photo 3 of 3 : UCIP_FA_2018_24427_43437.jpg

WS view: steel pipe and concrete riser on levee berm.

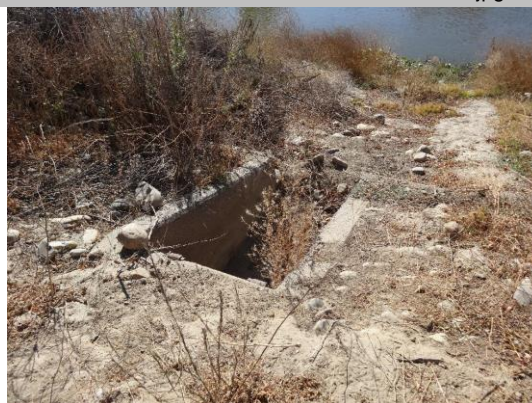
Photo 1 of 3 : UCIP_FA_2018_24435_43484.jpg

LM Start	2.62	Rating **	M	Issue No.	67	
LM End	2.62	Issue Type +	Ma	Location *		
Category	Supplemental			GPS Latitude/Longitude		
				Start		End
Item	DWR UCIP LMA Responsibility			37.448233 °	37.448233 °	
				-121.026521 °	-121.026521 °	
DWR ID	22086					
Comment Code						
Inspector Comment						
FS_ID:24435 DS_ID:22086 EP_NO: N/A Repair Type: Non-Urgent Crossing Status: Found UCIP Comments: 11/05/2013 Both pipe ends 70 ft off the levee center.Clearing and cleaning of inlet/outlet pipe needed. (P. Amatya - DWR UCIP) FIELD_STRUCT_DESC: 24-inch corrugated metal gravity drainage pipe through the levee, 12 feet below the crown. Flap gate on the waterside (WS) end. Concrete headwall on each end. Installed by USACE in 1961. [Additional Reference(s): DWR Levee Log, 1992. USACE San Joaquin O&M Manual 6, September 1961, (HLM 2.65)]. FS Date: 11/5/2013

WS view: U shaped headwall outlet structure 70 ft off the levee center.

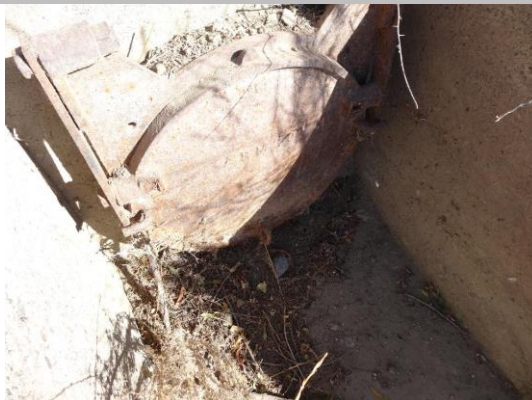
Photo 2 of 3 : UCIP_FA_2018_24435_43483.jpg

WS view: U shaped headwall outlet structure and pipe with flap gate.

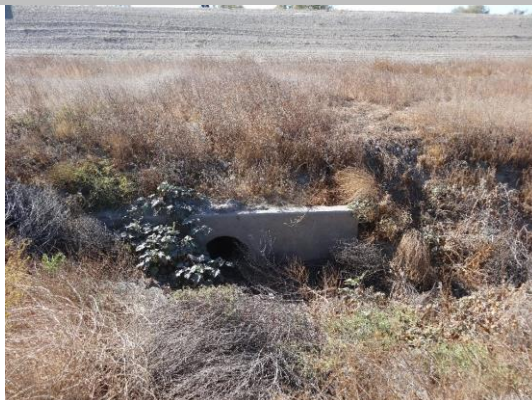
Photo 3 of 3 : UCIP_FA_2018_24435_43482.jpg

LS view: concrete headwall with CMP 70 ft off the levee center.

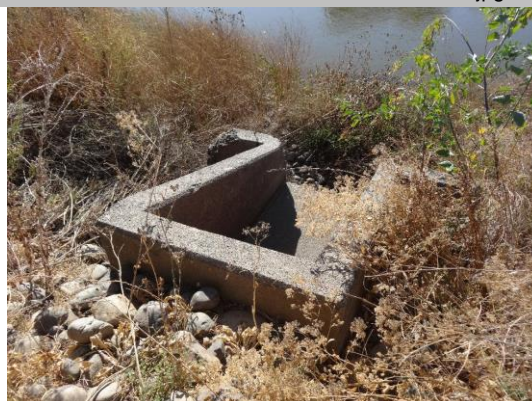
Photo 1 of 3 : UCIP_FA_2018_25023_45102.jpg

LM Start	2.68	Rating **	A/W	Issue No.	68
LM End	2.68	Issue Type +	Ma	Location *	
Category	Supplemental			GPS Latitude/Longitude	
				Start	End
Item	DWR UCIP LMA Responsibility			37.447475 °	37.447475 °
				-121.026017 °	-121.026017 °
DWR ID	22087				
Comment Code					
Inspector Comment					
FS_ID:25023					
DS_ID:22087					
EP_NO: N/A					
Repair Type: No Action Needed					
Crossing Status: Found					
UCIP Comments: 11/05/2013 Both pipe ends about 85 feet off the levee center. (P. Amatya - DWR UCIP)					
FIELD_STRUCT_DESC: 24-inch corrugated metal gravity drainage pipe through the levee, 20.3 feet below the crown. Flap gate on the waterside (WS) end. Concrete headwall on each end. Installed by USACE in 1961. [Additional Reference(s): DWR Levee Log, 1992. USACE San Joaquin O&M Manual 6, September 1961, (HLM 2.71)].					
FS Date: 11/5/2013

WS view: U typed concrete headwall on river bank.

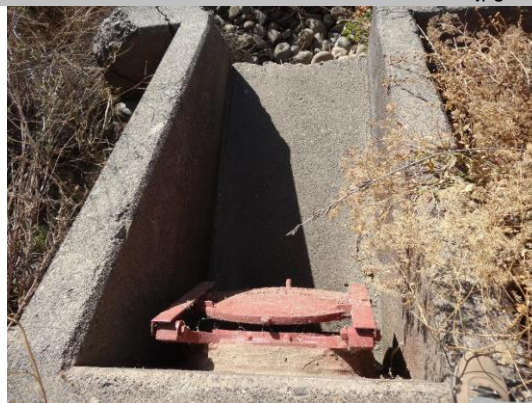
Photo 2 of 3 : UCIP_FA_2018_25023_45101.jpg

WS view: pipe, flap gate, and concrete headwall on river bank.

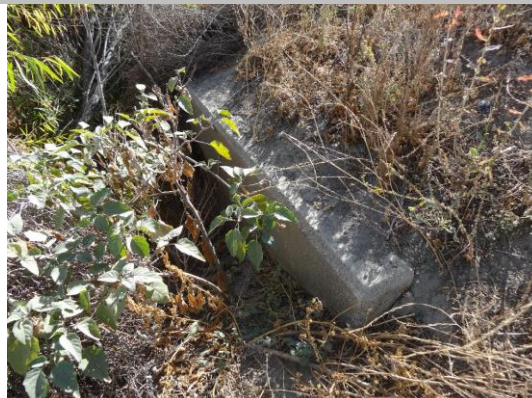
Photo 3 of 3 : UCIP_FA_2018_25023_45100.jpg

LM Start	2.68	Rating **	A/W	Issue No.	68 (cont)	
LM End	2.68	Issue Type +	Ma	Location *		
Category	Supplemental			GPS Latitude/Longitude		
				Start	End	
Item	DWR UCIP LMA Responsibility			37.447475 °	37.447475 °	
				-121.026017 °	-121.026017 °	
DWR ID	22087					
Comment Code						
Inspector Comment						
FS_ID:25023						
DS_ID:22087						
EP_NO: N/A						
Repair Type: No Action Needed						
Crossing Status: Found						
UCIP Comments: 11/05/2013 Both pipe ends about 85 feet off the levee center. (P. Amatya - DWR UCIP)						
FIELD_STRUCT_DESC: 24-inch corrugated metal gravity drainage pipe through the levee, 20.3 feet below the crown. Flap gate on the waterside (WS) end. Concrete headwall on each end. Installed by USACE in 1961. [Additional Reference(s): DWR Levee Log, 1992. USACE San Joaquin O&M Manual 6, September 1961, (HLM 2.71)].						
FS Date: 11/5/2013

LS view: pipe and concrete headwall off the levee toe.

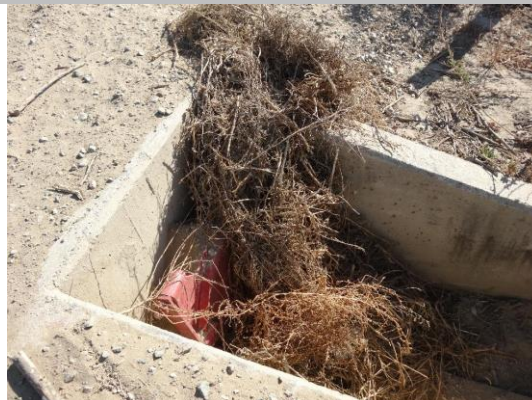
Photo 1 of 3 : UCIP_FA_2018_24443_43522.jpg

LM Start	2.93	Rating **	M	Issue No.	69	
LM End	2.93	Issue Type +	Ma	Location *		
Category	Supplemental			GPS Latitude/Longitude		
				Start		End
Item	DWR UCIP LMA Responsibility			37.443871 °		37.443871 °
				-121.025775 °		-121.025775 °
DWR ID	22088					
Comment Code						
Inspector Comment						
FS_ID:24443						
DS_ID:22088						
EP_NO: N/A						
Repair Type: Non-Urgent						
Crossing Status: Found						
UCIP Comments: 11/05/2013 - clear and clean debris (P. Amatya - DWR UCIP)						
FIELD_STRUCT_DESC: *ABANDONED* 24-inch corrugated metal gravity drainage pipe through the levee, 9.5 feet below the crown. Flap gate on the waterside (WS) end. Pipe open on the landside (LS) end. Concrete headwall on each end. [Additional Reference(s): DWR Levee Log, 1992. USACE San Joaquin O&M Manual 6, September 1961, (HLM 2.97)].						
FS Date: 11/5/2013

WS view: U typed concrete headwall on levee slope.

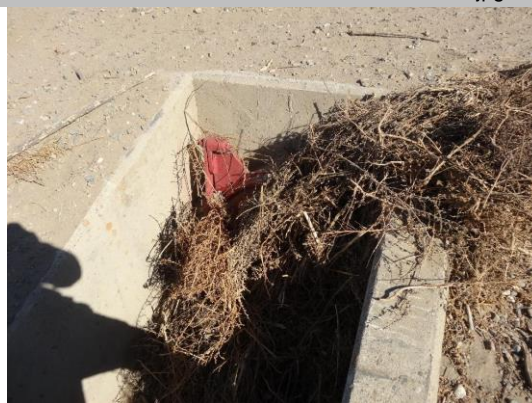
Photo 2 of 3 : UCIP_FA_2018_24443_43521.jpg

WS view: pipe, flap gate, and concrete headwall with debris blocking the outlet.

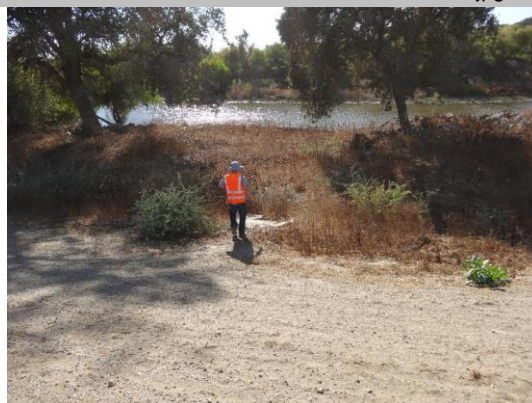
Photo 1 of 3 : UCIP_FA_2018_24469_43645.jpg

LM Start	3.29	Rating **	M	Issue No.	70	
LM End	3.29	Issue Type +	Ma	Location *		
Category	Supplemental			GPS Latitude/Longitude		
				Start	End	
Item	DWR UCIP LMA Responsibility			37.441213 °	37.441213 °	
				-121.021130 °	-121.021130 °	
DWR ID	22089					
Comment Code						
Inspector Comment						
FS_ID:24469 DS_ID:22089 EP_NO: N/A Repair Type: Non-Urgent Crossing Status: Found UCIP Comments: 11/05/2013 - cleaning required in inlet pipe.- new flap gate (P. Amatya - DWR UCIP) FIELD_STRUCT_DESC: *ABANDONED* 24-inch corrugated metal gravity drainage pipe through the levee, 12.5 feet below the crown. Flap gate on the waterside (WS) end. Concrete headwall on each end. [Additional Reference(s): DWR Levee Log, 1992. USACE San Joaquin O&M Manual 6, September 1961, (HLM 3.33)]. FS Date: 11/5/2013

WS view: U typed concrete headwall on levee toe

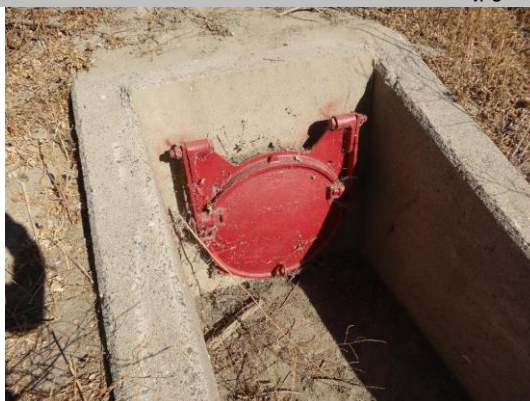
Photo 2 of 3 : UCIP_FA_2018_24469_43644.jpg

WS view: new flap gate, and U typed concrete headwall.

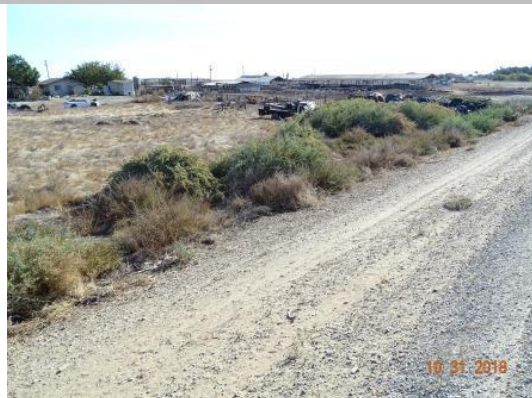
Photo 1 of 1 : FA_2018_RD2063_112_42_20181114_00125.jpg

LM Start	3.55	Rating **	M	Issue No.	42
LM End	3.57	Issue Type +	Ma	Location *	LS
Category	Earthen Levee			GPS Latitude/Longitude	
				Start	End
Item	Vegetation			37.437986 °	37.437667 °
				-121.018703 °	-121.018468 °
DWR ID	DWR_RD2063_01_f_2018_42				
Comment Code					
V1 : Control annual grass and weeds on the levee slopes and easements.					
Inspector Comment					
Control vegetation growth at toe.

Heavy brush growing at landside toe. (Fall 2018)

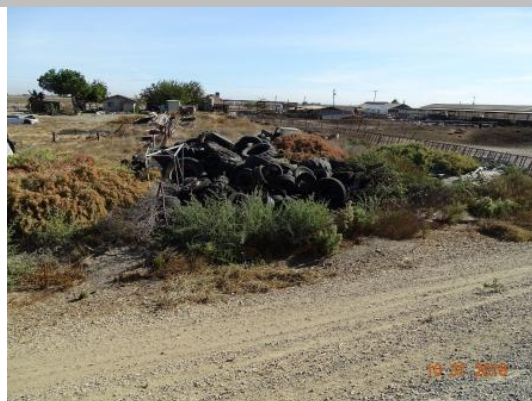
Photo 1 of 1 : FA_2018_RD2063_112_44_20181114_00134.jpg

LM Start	3.57	Rating **	U	Issue No.	44
LM End	3.57	Issue Type +	En	Location *	LS
Category	Earthen Levee			GPS Latitude/Longitude	
				Start	End
Item	Encroachments			37.437761 °	37.437761 °
				-121.018535 °	-121.018535 °
DWR ID	DWR_RD2063_01_f_2018_44				
Comment Code					
DE : Debris					
Inspector Comment					
Remove garbage at toe of levee.

View of tires and garbage left at the levee toe. (Fall 2018)

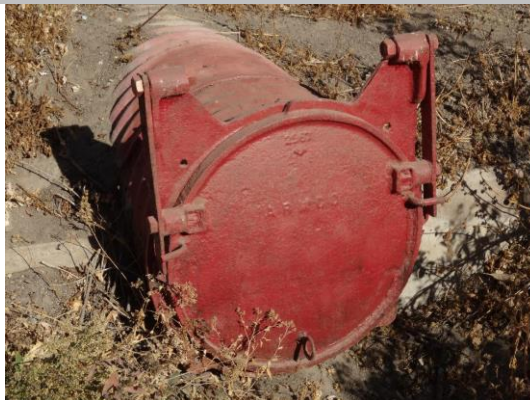
Photo 1 of 3 : UCIP_FA_2018_24485_43667.jpg

LM Start	3.64	Rating **	M	Issue No.	71	
LM End	3.64	Issue Type +	Ma	Location *		
Category	Supplemental			GPS Latitude/Longitude		
				Start	End	
Item	DWR UCIP LMA Responsibility			37.436845 °	37.436845 °	
				-121.017826 °	-121.017826 °	
DWR ID	22093					
Comment Code						
Inspector Comment						
FS_ID:24485 DS_ID:22093 EP_NO: N/A Repair Type: Non-Urgent Crossing Status: Found UCIP Comments: 11/05/2013 - new flap gate on waterside.- cleaning and clearing of inlet box needed. (P. Amatya - DWR UCIP) FIELD_STRUCT_DESC: 24-inch corrugated metal gravity drainage pipe through the levee, 12 feet below the crown. Flap gate and concrete saddle on the waterside (WS) end. Concrete drop inlet box on the landside (LS) end. Installed by USACE in 1961. [Additional Reference(s): DWR Levee Log, 1992. USACE San Joaquin O&M Manual 6, September 1961, (HLM 3.69)]. FS Date: 11/5/2013

WS view: pipe, flap gate, and concrete saddle on levee slope

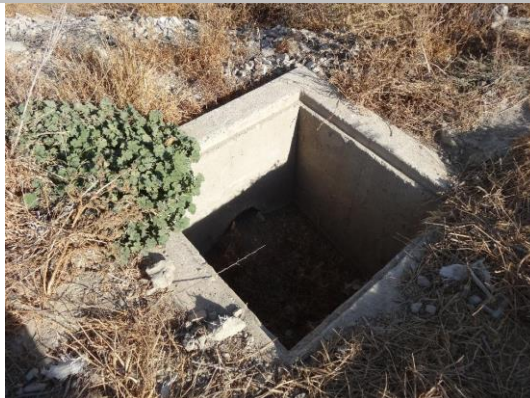
Photo 2 of 3 : UCIP_FA_2018_24485_43666.jpg

LS view: concrete drop inlet box on levee toe.

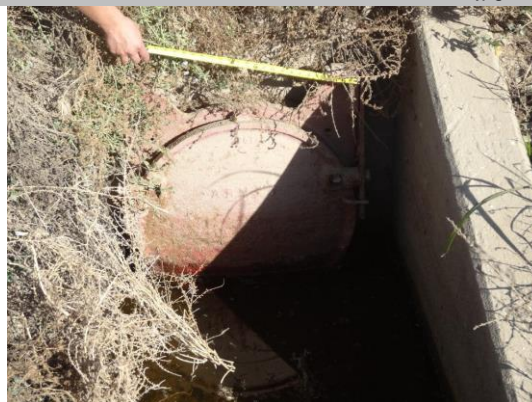
Photo 1 of 3 : UCIP_FA_2018_51821_43842.jpg

Comment Code					
Inspector Comment					
FS_ID:51821 DS_ID:22096 EP_NO: N/A Repair Type: No Action Needed Crossing Status: Found UCIP Comments: 05/11/2017 Review of photos indicate less than 1/4 of the inlet is silted in. Since the pipe is in good condition, it has been downgraded from Non-Urgent to No Action Needed. (K. Fazel - UCIP)11/05/2013:- new flap gate on waterside.- cleaning of outlet and inlet pipes required. (P. Amatya - DWR) FIELD_STRUCT_DESC: 24-inch corrugated metal gravity drainage pipe through the levee, 12 feet below the crown. Flap gate on the waterside (WS) end. Concrete headwall on each end. Installed by USACE in 1961. [Additional Reference(s): DWR Levee Log, 1992. USACE San Joaquin O&M Manual 6, September 1961, (HLM 4.08)]. FS Date: 11/5/2013

WS view: pipe, flap gate, and concrete headwall on drainage ditch.

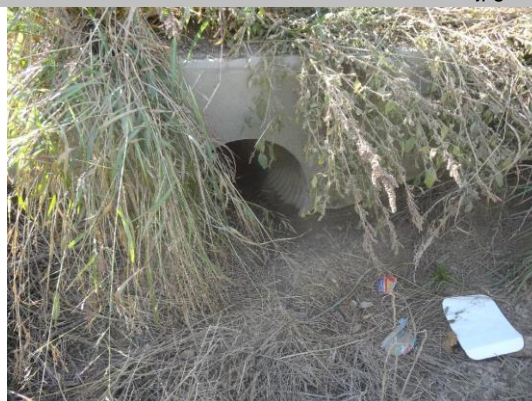
Photo 2 of 3 : UCIP_FA_2018_51821_43841.jpg

Comment Code						
Inspector Comment						
FS_ID:51821						
DS_ID:22096						
EP_NO: N/A						
Repair Type: No Action Needed						
Crossing Status: Found						
UCIP Comments: 05/11/2017 Review of photos indicate less than 1/4 of the inlet is silted in. Since the pipe is in good condition, it has been downgraded from Non-Urgent to No Action Needed. (K. Fazel - UCIP)11/05/2013:- new flap gate on waterside.- cleaning of outlet and inlet pipes required. (P. Amatya - DWR)						
FIELD_STRUCT_DESC: 24-inch corrugated metal gravity drainage pipe through the levee, 12 feet below the crown. Flap gate on the waterside (WS) end. Concrete headwall on each end. Installed by USACE in 1961. [Additional Reference(s): DWR Levee Log, 1992. USACE San Joaquin O&M Manual 6, September 1961, (HLM 4.08)].						
FS Date: 11/5/2013

LS view: CM pipe and concrete headwall on levee toe.

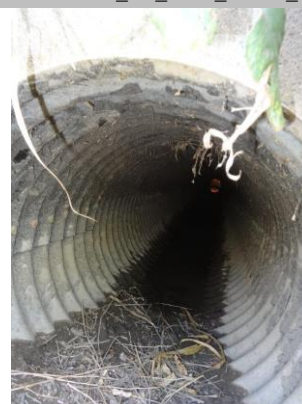
Photo 3 of 3 : UCIP_FA_2018_51821_43840.jpg

LS view: inside view of the CM pipe on levee toe.

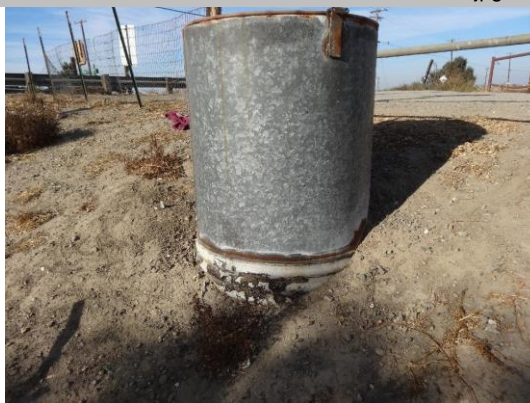
Photo 1 of 3 : UCIP_FA_2018_41746_43850.jpg

Comment Code					
Inspector Comment					
FS_ID:41746 DS_ID:22099 EP_NO: N/A Repair Type: Non-Urgent Crossing Status: Found UCIP Comments: 11/05/2013 Need to determine if annular space has been grouted or if repair/sleeving was done in accordance with a permit or Title 23. Slide gate not found in CM pipe riser on the waterward slope.Dense vegetation on waterside.Pipe only visible in CMP riser on waterside slope. (P. Amatya - DWR UCIP) FIELD_STRUCT_DESC: 24-inch corrugated metal irrigation discharge pipe through the levee, 10 feet below the crown. Smaller pipe sleeved through the 24-inch pipe. Slide gate in a corrugated metal pipe (CMP) riser on the waterside (WS) slope. Connects to a concrete pipe irrigation system. Installed by USACE in 1961. [Additional Reference(s): DWR Levee Log, 1992. USACE San Joaquin O&M Manual 6, September 1961, (HLM 4.16)]. FS Date: 11/5/2013

WS view: CMP riser on levee slope. Steel riser on top of CMP.

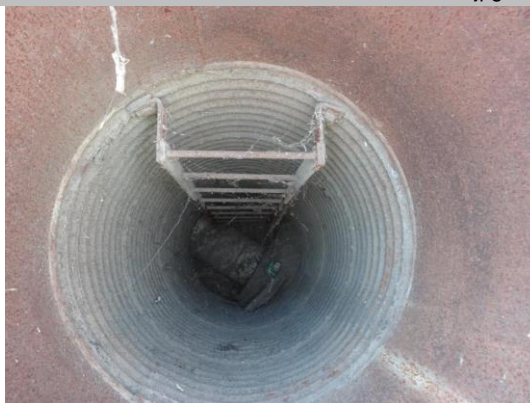
Photo 2 of 3 : UCIP_FA_2018_41746_43849.jpg

WS view: inside view of CMP riser on levee slope. Steel pipe and 24" CMP visible inside the riser.

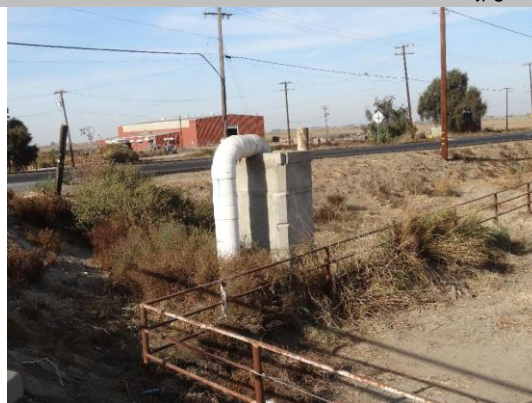
Photo 3 of 3 : UCIP_FA_2018_41746_43848.jpg

Comment Code						
Inspector Comment						
FS_ID:41746 DS_ID:22099 EP_NO: N/A Repair Type: Non-Urgent Crossing Status: Found UCIP Comments: 11/05/2013 Need to determine if annular space has been grouted or if repair/sleeving was done in accordance with a permit or Title 23. Slide gate not found in CM pipe riser on the waterward slope.Dense vegetation on waterside.Pipe only visible in CMP riser on waterside slope. (P. Amatya - DWR UCIP) FIELD_STRUCT_DESC: 24-inch corrugated metal irrigation discharge pipe through the levee, 10 feet below the crown. Smaller pipe sleeved through the 24-inch pipe. Slide gate in a corrugated metal pipe (CMP) riser on the waterside (WS) slope. Connects to a concrete pipe irrigation system. Installed by USACE in 1961. [Additional Reference(s): DWR Levee Log, 1992. USACE San Joaquin O&M Manual 6, September 1961, (HLM 4.16)]. FS Date: 11/5/2013

LS view: discharge pipe and concrete distribution box on levee toe.

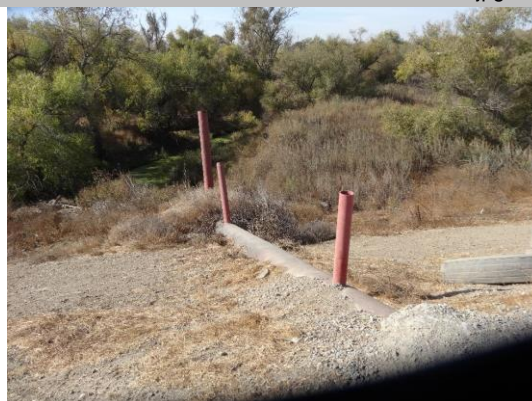
Photo 1 of 3 : UCIP_FA_2018_25025_45110.jpg

Comment Code						
Inspector Comment						
FS_ID:25025 DS_ID:24732 EP_NO: N/A Repair Type: Non-Urgent Crossing Status: Found UCIP Comments: 11/06/2013 - new pipe to pump.- overhead power line.- soil cover over the pipe seems not enough. (P. Amatya - DWR UCIP) FIELD_STRUCT_DESC: 24-inch steel drainage discharge pipe through the levee, immediately beneath the crown. A thin layer of dirt acts as cover for the pipe. Pump house on a steel structure in a drainage ditch on the landside (LS). Pump house and pipe on the LS look new. Old wooden walkway to the pump house. Three new air vents on the waterside (WS). Pipe opens on the WS. Exposed old pipe on the WS. FS Date: 11/6/2013

WS view: air vents (top- red) on exposed steel pipe.

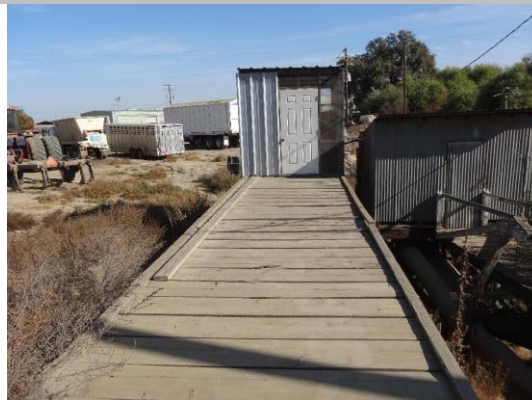
Photo 3 of 3 : UCIP_FA_2018_25025_45108.jpg

Comment Code						
Inspector Comment						
FS_ID:25025 DS_ID:24732 EP_NO: N/A Repair Type: Non-Urgent Crossing Status: Found UCIP Comments: 11/06/2013 - new pipe to pump.- overhead power line.- soil cover over the pipe seems not enough. (P. Amatya - DWR UCIP) FIELD_STRUCT_DESC: 24-inch steel drainage discharge pipe through the levee, immediately beneath the crown. A thin layer of dirt acts as cover for the pipe. Pump house on a steel structure in a drainage ditch on the landside (LS). Pump house and pipe on the LS look new. Old wooden walkway to the pump house. Three new air vents on the waterside (WS). Pipe opens on the WS. Exposed old pipe on the WS. FS Date: 11/6/2013

LS view: walkway to pump and pump house on levee slope.

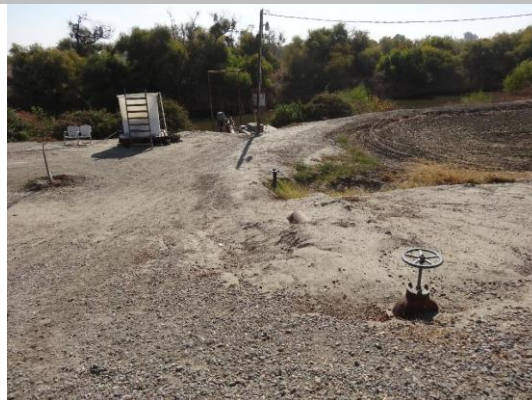
Photo 1 of 3 : UCIP_FA_2018_25028_45125.jpg

Comment Code					
Inspector Comment					
FS_ID:25028 DS_ID:22103 EP_NO: N/A Repair Type: Non-Urgent Crossing Status: Found UCIP Comments: 11/06/2013 Leaky pipe joint on landside where pipe daylights.Power pole on waterside. (P. Amatya - DWR UCIP) FIELD_STRUCT_DESC: 10-inch steel irrigation discharge pipe through the levee, 4 feet below the crown. Pump at the top of the riverbank. Gate valve on the waterside (WS) slope. Siphon breaker on the landside (LS) slope. Pipe daylights halfway down the LS slope and empties into a concrete standpipe at the LS toe. Installed by USACE in 1961. [Additional Reference(s): DWR Levee Log, 1992. USACE San Joaquin O&M Manual 6, September 1961, (HLM 4.65)]. FS Date: 11/6/2013

WS view: overview of waterside- gate valve and power pole on levee slope.

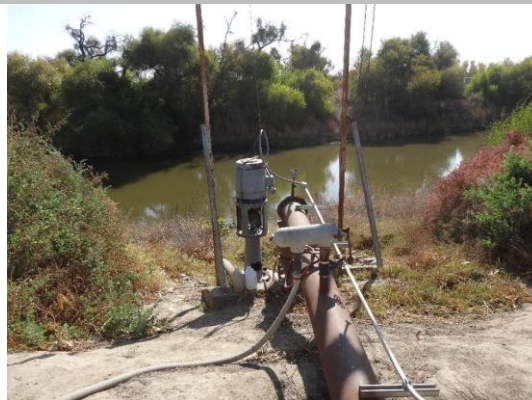
Photo 2 of 3 : UCIP_FA_2018_25028_45124.jpg

Comment Code						
Inspector Comment						
FS_ID:25028						
DS_ID:22103						
EP_NO: N/A						
Repair Type: Non-Urgent						
Crossing Status: Found						
UCIP Comments: 11/06/2013 Leaky pipe joint on landside where pipe daylights.Power pole on waterside. (P. Amatya - DWR UCIP)						
FIELD_STRUCT_DESC: 10-inch steel irrigation discharge pipe through the levee, 4 feet below the crown. Pump at the top of the riverbank.						
Gate valve on the waterside (WS) slope. Siphon breaker on the landside (LS) slope. Pipe daylights halfway down the LS slope and empties into a concrete standpipe at the LS toe. Installed by USACE in 1961. [Additional Reference(s): DWR Levee Log, 1992. USACE San Joaquin O&M Manual 6, September 1961, (HLM 4.65)].						
FS Date: 11/6/2013

WS view: pump, pipe and other appurtenances on levee toe.

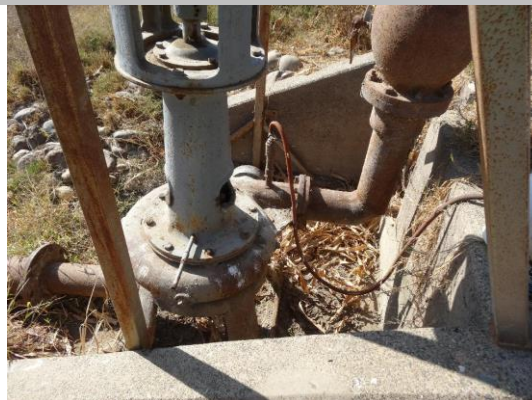
Photo 3 of 3 : UCIP_FA_2018_25028_45123.jpg

WS view: U type headwall and pump on river bank.

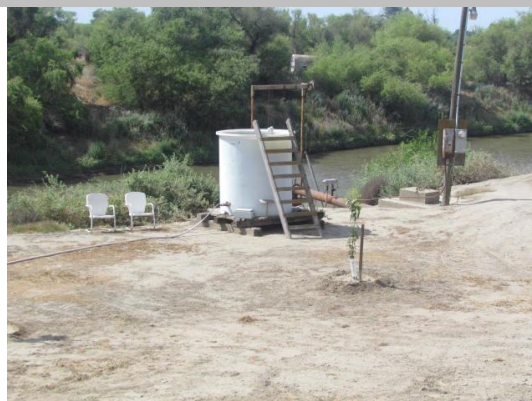
Photo 1 of 3 : FA_2018_RD2063_112_31_20180911_00004.jpg

LM Start	4.60	Rating **	M	Issue No.	31 (cont)
LM End	4.60	Issue Type +	En	Location *	WS

Looking west at water tank on waterward berm.

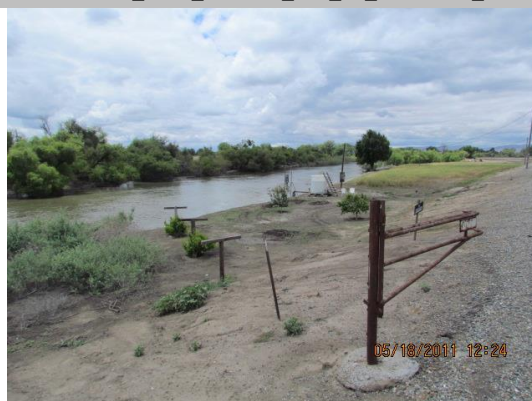
Photo 2 of 3 : FA_2018_RD2063_112_31_20180911_00005.jpg

Looking south at grapevines and fruit trees on waterside berm.

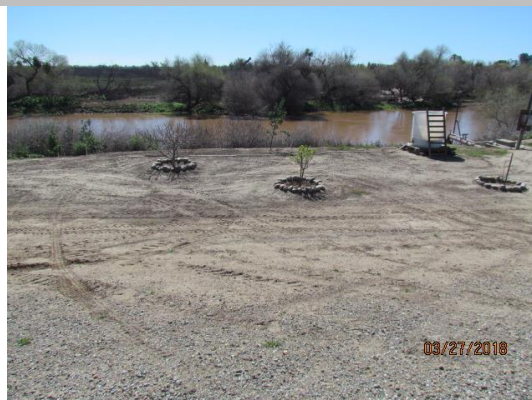
Photo 3 of 3 : FA_2018_RD2063_112_31_20180911_00006.jpg

LM Start	4.60	Rating **	M	Issue No.	31 (cont)
LM End	4.60	Issue Type +	En	Location *	WS

Looking west at trees with retaining wall around trees. (Spring 2018)

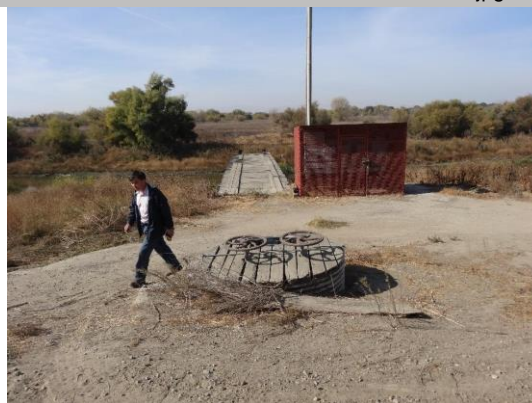
Photo 1 of 3 : UCIP_FA_2018_41669_45131.jpg

Comment Code						
Inspector Comment						
FS_ID:41669 DS_ID:22105 EP_NO: N/A Repair Type: Non-Urgent Crossing Status: Found UCIP Comments: 11/06/2013 Abandoned pipe should be done so properly.- rubber pipe attached to steel pipe on waterside.- a concrete standpipe on landside too.- overhead power line.- abandoned pipe and pile structure. Abandoned timber walkway on waterside. (P. Amatya - DWR UCIP) FIELD_STRUCT_DESC: 1 of 2: 12-inch concrete encased steel irrigation discharge pipe through the levee, 9 feet below the crown. Two pumps on a floating structure in the river. Two slide gates in a 72-inch corrugated metal pipe (CMP) riser on the waterside (WS) slope. Pipe discharges into a concrete distribution box on the landside (LS) toe. Installed by USACE in 1961. [Additional Reference(s): DWR Levee Log, 1992, 14-inch and 16-inch pipes referenced. USACE San Joaquin O&M Manual 6, September 1961, (HLM 5.13), 14-inch and 16-inch pipes referenced]. FS Date: 11/6/2013

WS view: CMP riser, abandoned walkway, power pole on levee slope.

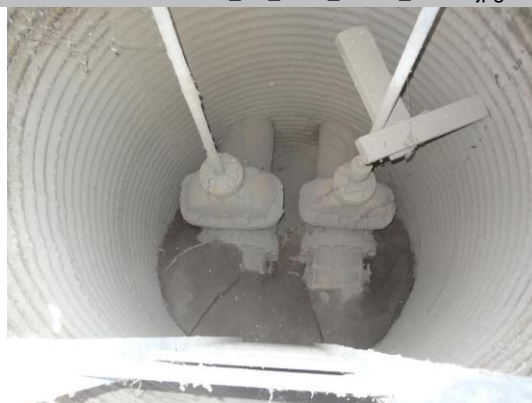
Photo 2 of 3 : UCIP_FA_2018_41669_45130.jpg

WS view: two gate valves inside CMP riser on levee slope.

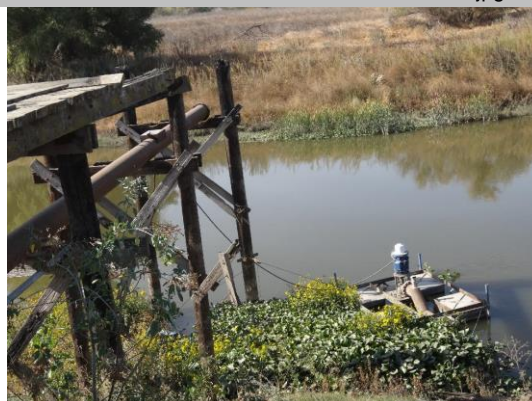
Photo 3 of 3 : UCIP_FA_2018_41669_45129.jpg

Comment Code						
Inspector Comment						
FS_ID:41669 DS_ID:22105 EP_NO: N/A Repair Type: Non-Urgent Crossing Status: Found UCIP Comments: 11/06/2013 Abandoned pipe should be done so properly.- rubber pipe attached to steel pipe on waterside.- a concrete standpipe on landside too.- overhead power line.- abandoned pipe and pile structure. Abandoned timber walkway on waterside. (P. Amatya - DWR UCIP) FIELD_STRUCT_DESC: 1 of 2: 12-inch concrete encased steel irrigation discharge pipe through the levee, 9 feet below the crown. Two pumps on a floating structure in the river. Two slide gates in a 72-inch corrugated metal pipe (CMP) riser on the waterside (WS) slope. Pipe discharges into a concrete distribution box on the landside (LS) toe. Installed by USACE in 1961. [Additional Reference(s): DWR Levee Log, 1992, 14-inch and 16-inch pipes referenced. USACE San Joaquin O&M Manual 6, September 1961, (HLM 5.13), 14-inch and 16-inch pipes referenced]. FS Date: 11/6/2013

WS view: abandoned walkway, pipe (left) and pump on floating structure in the river.

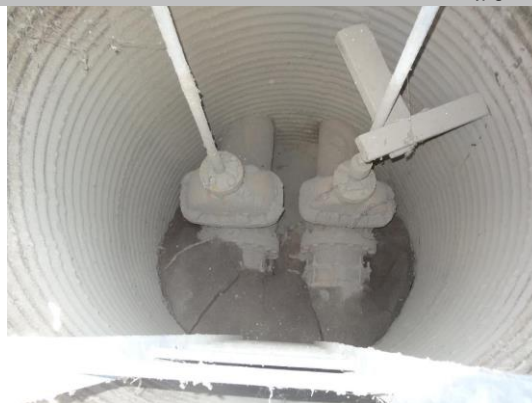
Photo 2 of 3 : UCIP_FA_2018_41670_43904.jpg

Comment Code						
Inspector Comment						
FS_ID:41670 DS_ID:22123 EP_NO: N/A Repair Type: Non-Urgent Crossing Status: Found UCIP Comments: 11/06/2013 Any abandoned pipes should be verified as having been abandoned properly. - abandoned walkway, pile structure and steel pipe.- concrete standpipe on landside toe.- overhead power line. (P. Amatya - DWR UCIP) FIELD_STRUCT_DESC: 2 of 2: 12-inch concrete encased steel irrigation discharge pipe through the levee, 9 feet below the crown. Two pumps on a floating structure in the river. Two slide gates in a 72-inch corrugated metal pipe (CMP) riser on the waterside (WS) slope. Pipe discharges into a concrete distribution box on the landside (LS) toe. Installed by USACE in 1961. [Additional Reference(s): DWR Levee Log, 1992, 14-inch and 16-inch pipes referenced. USACE San Joaquin O&M Manual 6, September 1961, (HLM 5.13), 14-inch and 16-inch pipes referenced]. FS Date: 11/6/2013

WS view: two gate valves inside CMP riser on levee slope.

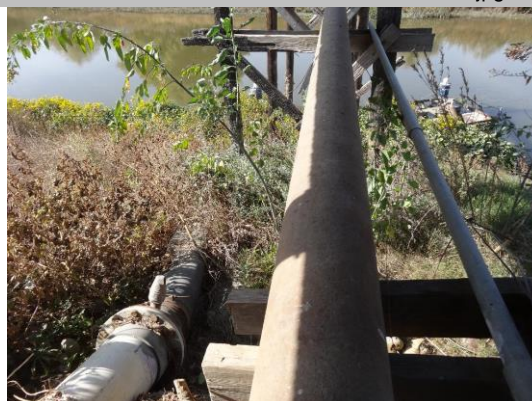
Photo 3 of 3 : UCIP_FA_2018_41670_43903.jpg

Comment Code						
Inspector Comment						
FS_ID:41670 DS_ID:22123 EP_NO: N/A Repair Type: Non-Urgent Crossing Status: Found UCIP Comments: 11/06/2013 Any abandoned pipes should be verified as having been abandoned properly. - abandoned walkway, pile structure and steel pipe.- concrete standpipe on landside toe.- overhead power line. (P. Amatya - DWR UCIP) FIELD_STRUCT_DESC: 2 of 2: 12-inch concrete encased steel irrigation discharge pipe through the levee, 9 feet below the crown. Two pumps on a floating structure in the river. Two slide gates in a 72-inch corrugated metal pipe (CMP) riser on the waterside (WS) slope. Pipe discharges into a concrete distribution box on the landside (LS) toe. Installed by USACE in 1961. [Additional Reference(s): DWR Levee Log, 1992, 14-inch and 16-inch pipes referenced. USACE San Joaquin O&M Manual 6, September 1961, (HLM 5.13), 14-inch and 16-inch pipes referenced]. FS Date: 11/6/2013

WS view: abandoned steel pipe (right), rubber pipe attached to steel pipe to pump on floating structure in the river.

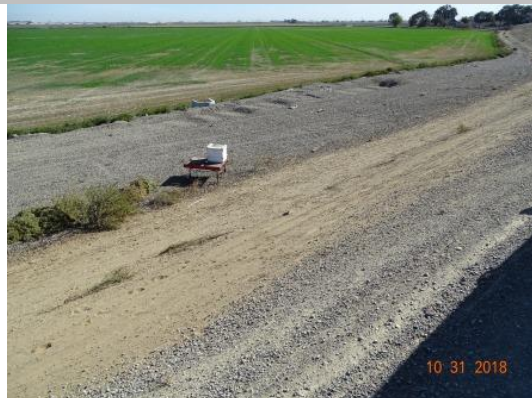
Photo 1 of 1 : FA_2018_RD2063_112_47_20181114_00128.jpg

LM Start	5.49	Rating **	M	Issue No.	47
LM End	5.49	Issue Type +	En	Location *	LS
Category	Earthen Levee			GPS Latitude/Longitude	
				Start	End
Item	Encroachments			37.421380 °	37.421380 °
				-121.001768 °	-121.001768 °
DWR ID	DWR_RD2063_01_f_2018_47				
Comment Code					
EQ : Equipment					
Inspector Comment					
Remove beehive at the levee toe.

View of beehive on levee toe. (Fall 2018)

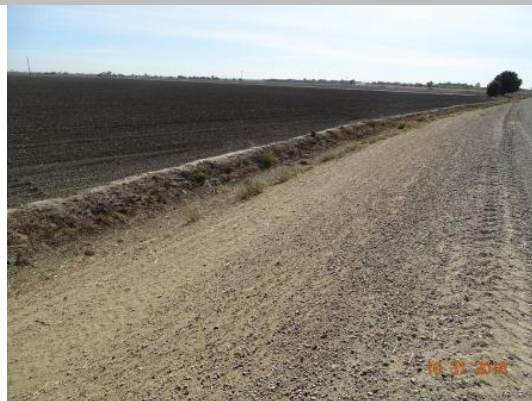
Photo 1 of 1 : FA_2018_RD2063_112_48_20181114_00129.jpg

LM Start	5.81	Rating **	M	Issue No.	48
LM End	5.90	Issue Type +	En	Location *	LS
Category	Earthen Levee			GPS Latitude/Longitude	
				Start	End
Item	Encroachments			37.418160 °	37.416898 °
				-120.997686 °	-120.997409 °
DWR ID	DWR_RD2063_01_f_2018_48				
Comment Code					
DT : Ditch					
Inspector Comment					
There is a small ditch running along the landside toe.

View of ditch along levee toe. (Fall 2018)

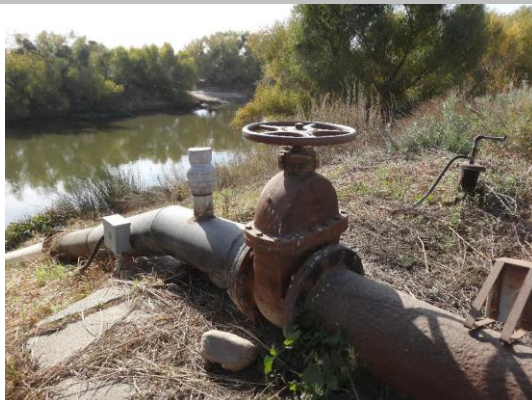
Photo 1 of 3 : UCIP_FA_2018_24628_43938.jpg

Comment Code						
Inspector Comment						
FS_ID:24628 DS_ID:22108 EP_NO: 4062 Repair Type: Non-Urgent Crossing Status: Found UCIP Comments: 11/06/2013 Abandoned pipe also found adjacent to this pipe. Needs proper abandonment.Soil erosion under pipe on waterside. No pipe visible on landside.Overhead powerline. (P. Amatya - DWR UCIP) FIELD_STRUCT_DESC: 12-inch polyvinyl chloride (PVC) irrigation discharge pipe through the levee, 3 feet below the crown. Floating pump in the river. Gate valve and air vent on the waterside (WS) berm. Service pole with overhead line on the WS shoulder. (Plans for an existing pump with discharge pipe through the levee authorized under Permit No. 4062, 1962 - John W. Greer). [Additional Reference(s): DWR Levee Log, 1992]. FS Date: 11/6/2013

WS view: steel pipe, gate valve, air vent on levee berm.

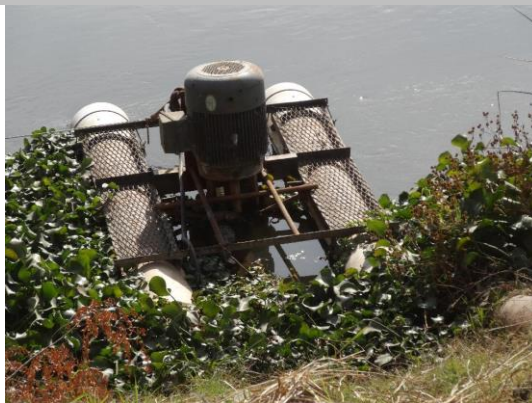
Photo 2 of 3 : UCIP_FA_2018_24628_43937.jpg

WS view: pump on floating structure in the stream.

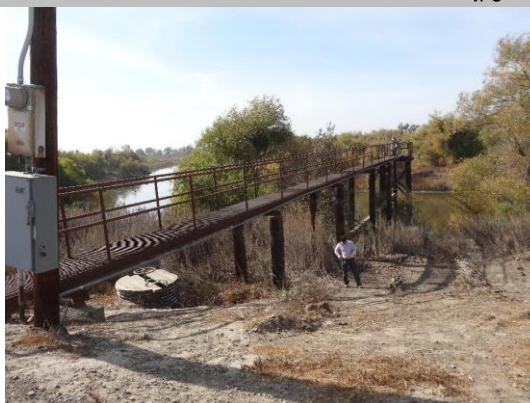
Photo 1 of 3 : UCIP_FA_2018_24629_43943.jpg

Comment Code					
Inspector Comment					
FS_ID:24629 DS_ID:22109 EP_NO: 13541 Repair Type: Non-Urgent Crossing Status: Found UCIP Comments: 11/06/2013 - erosion around CMP riser on waterside- no U type headwall found on landside.- no pipe found on landside. (P. Amatya - DWR UCIP) FIELD_STRUCT_DESC: 16-inch steel irrigation discharge pipe through the levee, 10 feet below the crown. Pump on the riverbank. Gate valve in a corrugated metal pipe (CMP) riser on the waterside (WS) slope. Concrete U-shaped headwall on the landside (LS) end. Installed by USACE in 1961. (Plans to construct an elevated platform and replace a centrifugal pump with a new vertical pump on the riverbank authorized under Permit No. 13541, 1982 - Joaquin Cabral). [Additional Reference(s): DWR Levee Log, 1992. USACE San Joaquin O&M Manual 6, September 1961, (HLM 7.08), 10-inch pipe referenced]. FS Date: 11/6/2013

WS view: power pole, walkway to pump, CMP riser, and pipe on waterside slope.

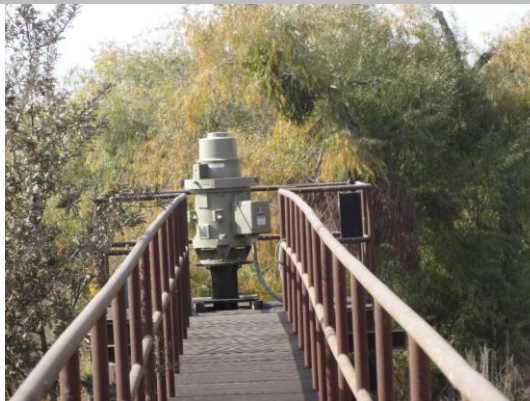
Photo 2 of 3 : UCIP_FA_2018_24629_43942.jpg

WS view: walkway to pump and pump on pile structure in the stream.

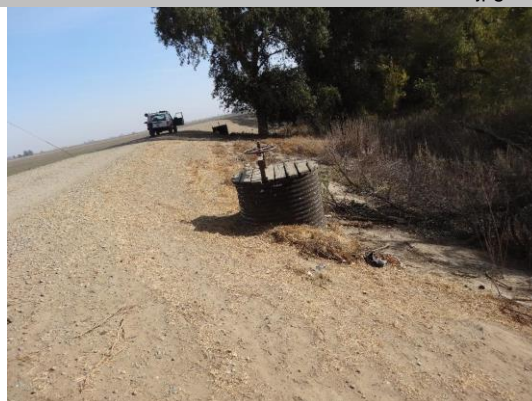
Photo 1 of 3 : UCIP_FA_2018_24632_43953.jpg

Comment Code					
Inspector Comment					
FS_ID:24632					
DS_ID:22110					
EP_NO: N/A					
Repair Type: No Action Needed					
Crossing Status: Found					
UCIP Comments: 11/06/2013 No pipe visible on landside.Flap gate through the levee, 25.5 feet below the crown. Slide gate in a corrugated not found on the waterside end. Concrete "U" headwalls not found on ends of pipe. (P. Amatya - DWR UCIP)					
FIELD_STRUCT_DESC: 36-inch corrugated metal gravity drainage pipe through the levee, 25.5 feet below the crown. Slide gate in a corrugated metal pipe (CMP) riser on the waterside (WS) slope. Flap gate on the WS end. Concrete U-shaped headwall on each end. Installed by USACE in 1961. [Additional Reference(s): DWR Levee Log, 1992. USACE San Joaquin O&M Manual 6, September 1961, (HLM 7.61)].					
FS Date: 11/6/2013

WS view: CMP riser on levee slope. No pipe visible on levee slope.

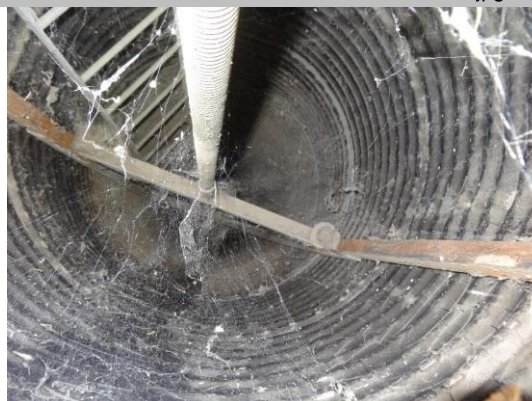
Photo 2 of 3 : UCIP_FA_2018_24632_43952.jpg

Comment Code						
Inspector Comment						
FS_ID:24632						
DS_ID:22110						
EP_NO: N/A						
Repair Type: No Action Needed						
Crossing Status: Found						
UCIP Comments: 11/06/2013 No pipe visible on landside.Flap gate not found on the waterside end. Concrete "U" headwalls not found on ends of pipe. (P. Amatya - DWR UCIP)						
FIELD_STRUCT_DESC: 36-inch corrugated metal gravity drainage pipe through the levee, 25.5 feet below the crown. Slide gate in a corrugated metal pipe (CMP) riser on the waterside (WS) slope. Flap gate on the WS end. Concrete U-shaped headwall on each end. Installed by USACE in 1961. [Additional Reference(s): DWR Levee Log, 1992. USACE San Joaquin O&M Manual 6, September 1961, (HLM 7.61)].						
FS Date: 11/6/2013

WS view: slide gate in CMP riser on levee slope.

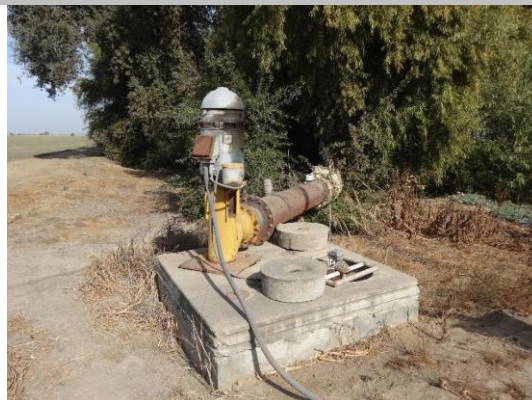
Photo 3 of 3 : UCIP_FA_2018_24632_43951.jpg

LS view: concrete distribution box on levee toe. Pump on the box discharges water into irrigation ditch.

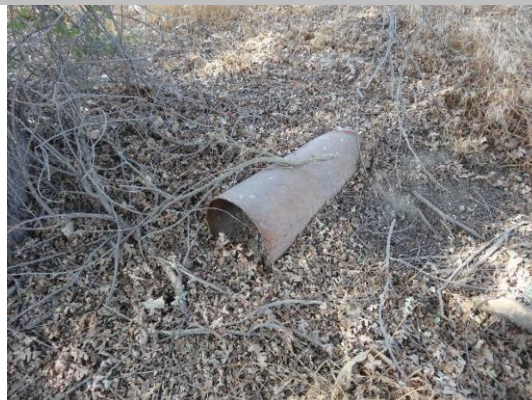
Photo 2 of 3 : UCIP_FA_2018_25031_45140.jpg

Comment Code						
Inspector Comment						
FS_ID:25031						
DS_ID:22111						
EP_NO: N/A						
Repair Type: Non-Urgent						
Crossing Status: Found						
UCIP Comments: 11/06/2013 Pump mounted on top of concrete pipe sump not found on the waterside. Concrete standpipe not found on the landward side.Looks abandoned. (P. Amatya - DWR UCIP)						
FIELD_STRUCT_DESC: *ABANDONED* 12-inch concrete encased steel drainage discharge pipe through the levee, 7 feet below the crown. Slide gate in a corrugated metal pipe (CMP) riser on the waterside (WS) slope. Pipe open on both ends. Installed by USACE in 1961. [Additional Reference(s): DWR Levee Log, 1992. USACE San Joaquin O&M Manual 6, September 1961, (HLM 7.62), 10-inch pipe referenced].						
FS Date: 11/6/2013

WS view: steel pipe with open-end on waterside slope.

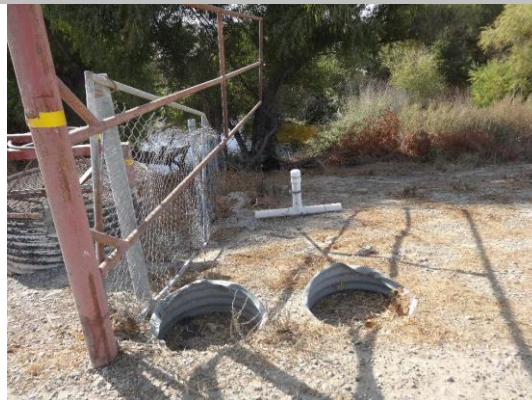
Photo 1 of 3 : UCIP_FA_2018_24651_44005.jpg

Comment Code						
Inspector Comment						
FS_ID:24651 DS_ID:22124 EP_NO: N/A Repair Type: Non-Urgent Crossing Status: Found UCIP Comments: 10/27/2017 This structure is inspected annually under the Structure and Channel Summer Inspection (part of the Levee Inspection Program) conducted by the DWR Flood Project Integrity and Inspection Branch (FPIIB). (DWR UCIP - O. Magana) 11/06/2013 - working during field inspection.- blocked siphon breaker. (P. Amatya - DWR UCIP) FIELD_STRUCT_DESC: 1 of 2: 16-inch steel drainage discharge pipe through the levee, 3.5 feet below the crown. Siphon breaker in a corrugated metal pipe (CMP) riser on the waterside (WS) slope. Flap gate on the WS end. Pump on a timber pile structure on the landside (LS). Timber walkway from levee to pump structure. [Additional Reference(s): DWR Levee Log, 1992. USACE San Joaquin O&M Manual 6, September 1961, (HLM 8.60)]. FS Date: 11/6/2013

WS view: two siphon breakers in CMP risers on levee slope.

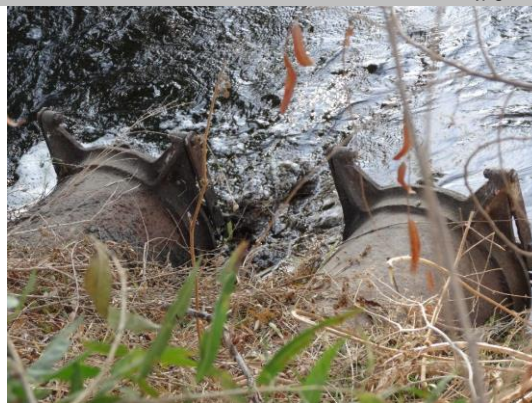
Photo 2 of 3 : UCIP_FA_2018_24651_44004.jpg

WS view: two flap gates on outfall pipe ends.

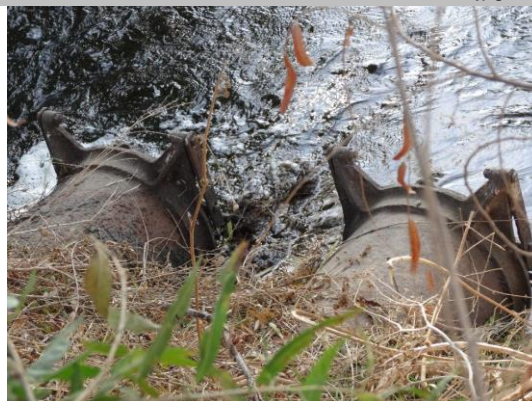
Photo 2 of 3 : UCIP_FA_2018_24652_44007.jpg

WS view: two flap gates on outfall pipe ends.

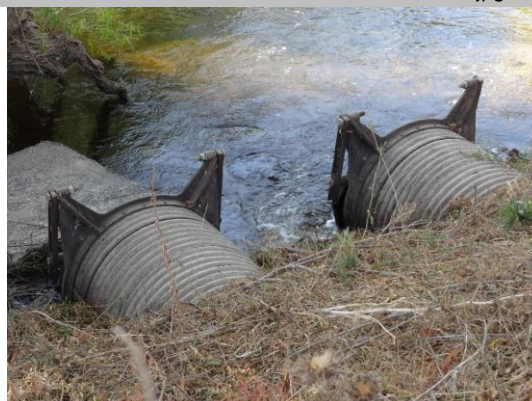
Photo 1 of 3 : UCIP_FA_2018_24650_44002.jpg

WS view: two flap gates on outfall pipe ends.

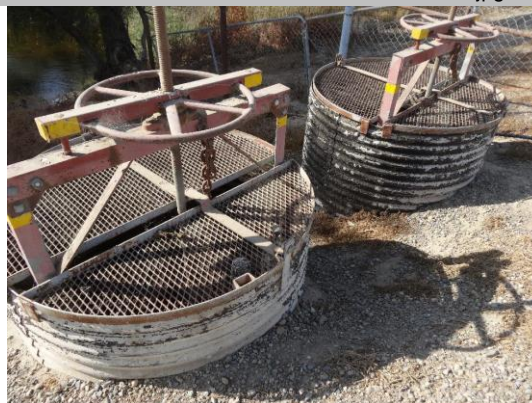
Photo 2 of 3 : UCIP_FA_2018_24650_44001.jpg

WS view: two slide gates in CMP risers on levee slope.
